Battery Failure on the Electric Propulsion Space Experiment (ESEX)

November 2001

Special Report

**AIR FORCE RESEARCH LABORATORY
AIR FORCE MATERIEL COMMAND
EDWARDS AIR FORCE BASE CA 93524-7048**

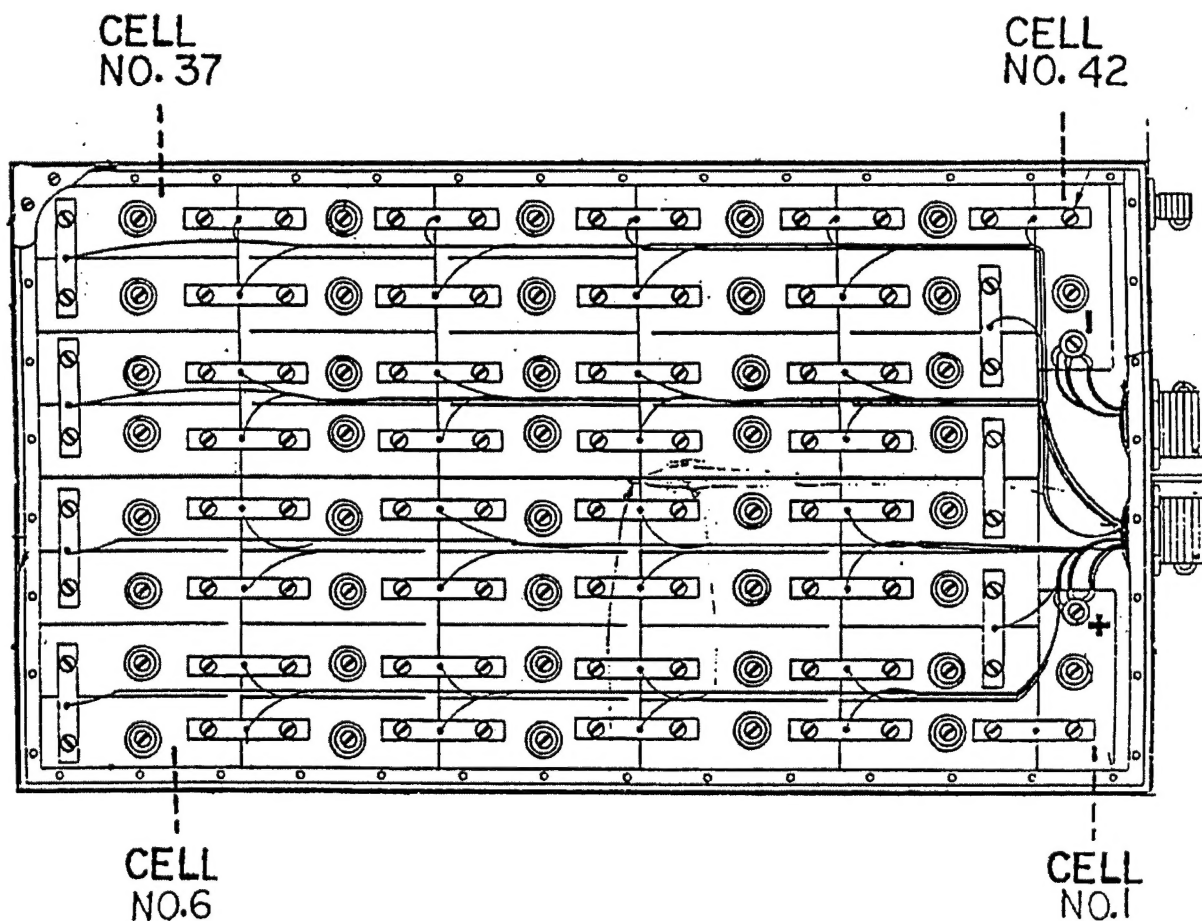
Figure 2. ESEX Battery Sub-Assembly Drawing Showing the Layout for the 42 Cells

layer copper strap (128 straps total, each strap had a resistance of 0.047 mΩ), bolted to the cell terminals. The completed sub-assembly then had a layer of potting encapsulate (FR-88 epoxy filled with microscopic glass beads) over the cells, covering the cell interconnects, leaving only the cell vents open to the interior of the battery sub-assembly chassis. Each sub-assembly also has a relief valve (cracking pressure of 3-8 psi) to vent over-pressure through its mounting panel to the outside of the flight unit.

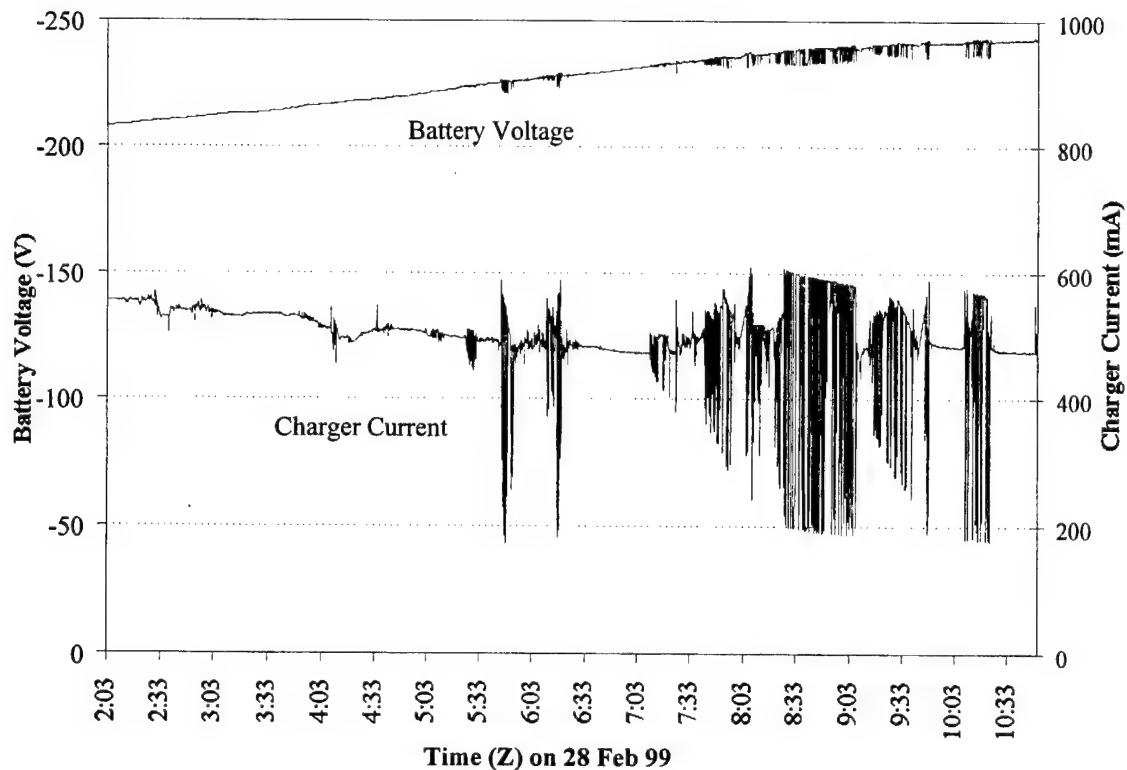
Figure 3. Typical Battery Charging Circuit Instability

turn-on, however, the charger output was less than 0.6 A, and decreasing. Although the charging circuit was operating at this lower output current, the charging proceeded nominally and was continued while the data was being monitored. As charging progressed over the next 48 hours, the output current remained stable around 0.57 A until the battery voltage approached -225 Vdc. At this point, as shown in Figure 3, the output current from the charging circuit began cycling on and off, resulting in oscillations of the open circuit battery voltage, charger output current, and even on the ARGOS 28 Vdc main bus current and voltage (not shown here). Initially, this was thought to be a result of higher-than-expected internal battery impedance as the charging progressed and the battery cooled – exacerbated by a low rate of charge. As the battery impedance is increased, the current loop control circuit in the battery charger becomes unstable, and results in the charger cycling on and off. This impedance was determined by taking the ratio of the change in battery voltage to the change in battery charge current. Near the first charging cycle, this impedance was calculated to be approximately $13\ \Omega$ – lending further credence to this proposed source of charging instability.

The ESEX failure suggests an electrolyte expulsion problem as was concluded in the write-up. In Figure 3, the first indications of problems are evident. Between 5:33 and 6:03 Z, the battery voltage is seen to drop about 6.0 volts. The granularity of the data appears to be too coarse to be able to see a short circuit within a single cell. The 6-volt drop suggests a short circuit to ground. In addition, there could have been a short circuit within a cell that actually melted the cell case allowing electrolyte to leak out and form a shorting path to the grounded battery box. That is, the electrolyte path could come from a hole melted in the cell case or from electrolyte being expelled out through the cell vent. Since a hole in the cell case resulted in the failure of the ESEX battery several years ago, this same problem may have initiated the short to the battery box in the flight battery. In Figure 5, the short to ground has grown to a much more significant short circuit. Silver-zinc cells have the capability of extremely high rates of internal discharge during a short circuit inside a cell. They have been known to catch fire during these events. The cell cases are made from combustible plastic materials. At the elevated temperatures of a fire, the silver oxide material will disassociate liberating oxygen that will encourage the fire. All of this thermal energy can produce steam as the electrolyte is heated above its boiling point.

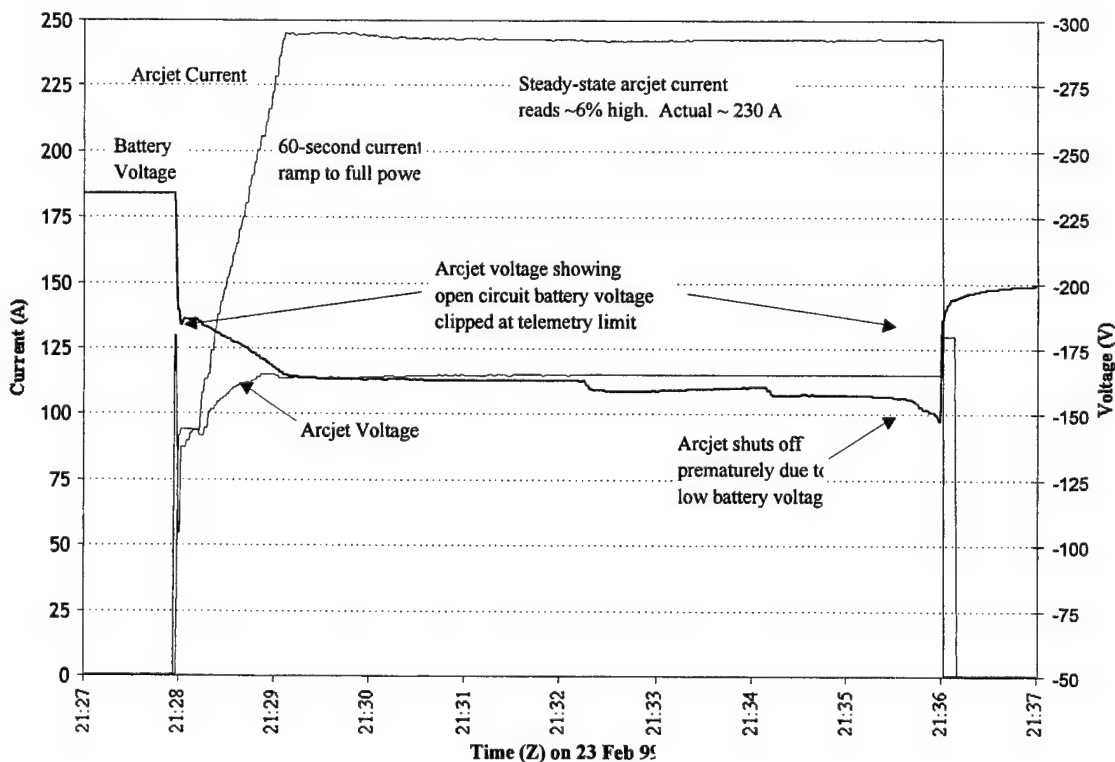
Figure 4. Example of a Premature Arcjet Firing Shut-off as a Result of the Low Battery Output Voltage. Data is Taken from Firing #4.

unstable PCU and arcjet operation, and eventually extinguished the thruster. The duration of each firing from #4 through #8 steadily decreased from 482 seconds to 42 seconds, as the battery performance deteriorated. After firing #7, an attempt to recondition the battery was made by performing a deep discharge through the existing bleed resistors, and restarting the charge. The initial plan was to wait until the battery was at a full state of charge (indicated by the charger circuit shutting off at the upper voltage limit) before attempting the next firing. After more than 19 days, however, the charger was commanded off and a firing was attempted. As indicated above, the duration of firing #8 showed the reconditioning did not have the desired effect.

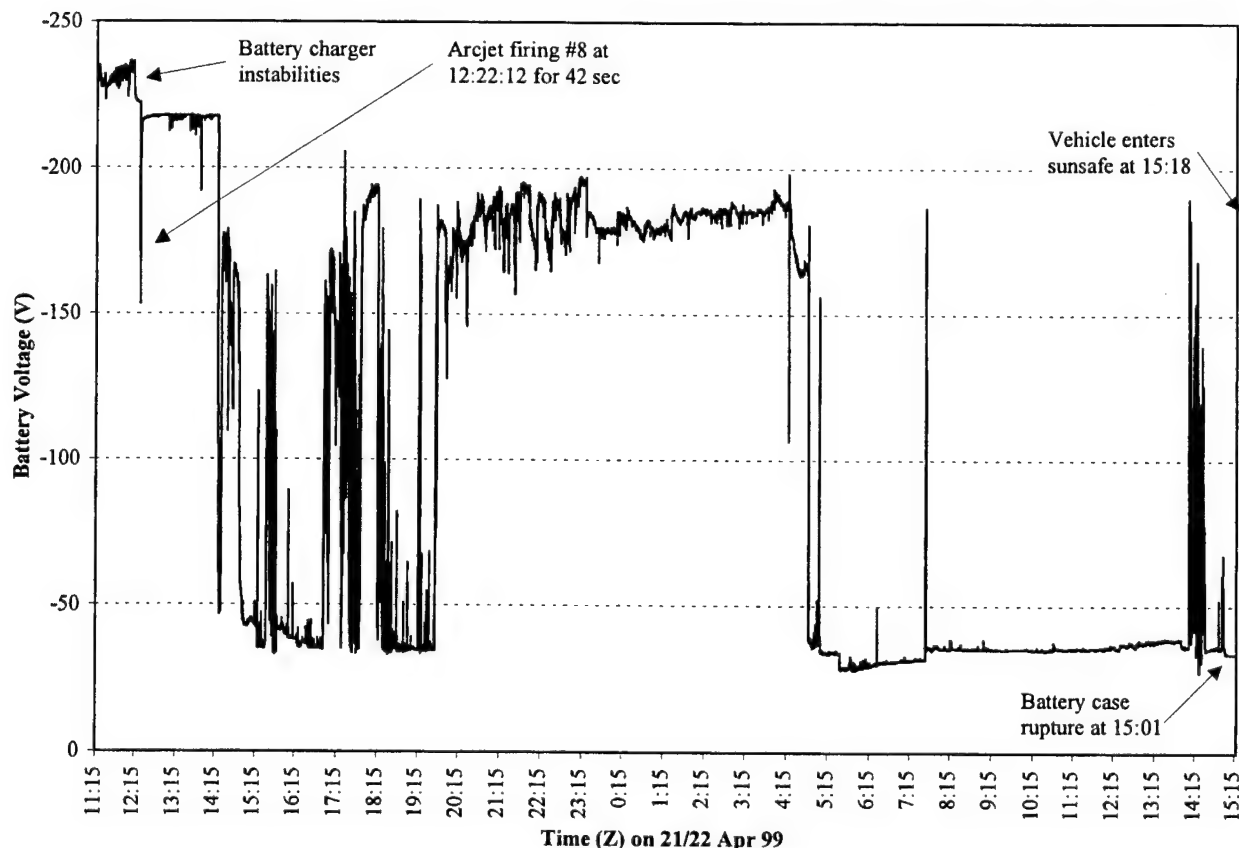
Following firing #8, the battery voltage fluctuated erratically between -175 and -200 Vdc with periodic drops as low as -30 Vdc – where it eventually stabilized, as shown in Figure 5. This behavior lasted approximately 24 hours until the battery sub-assembly on panel #1 had a catastrophic failure as a result of a short circuit. As the energy in the cell was discharging internally through the short circuit, there was a dramatic increase in the battery temperature and pressure as hydrogen gas was being generated from electrolyte decomposition. This process continued until there was a breach of the battery case and a release of this super-heated gas internal to the ESEX flight unit on 22 Apr 99 at 1501 Z. This gas release was likely directed at panel #3, since a 40 °F increase in temperature on this panel was observed over the course of a few seconds. This gas was eventually vented into space, causing a dramatic attitude disturbance

Figure 5. Battery Voltage Fluctuations Following the Final Arcjet Firing (#8) Ultimately Resulting in the Short Circuit

on the vehicle just prior to an umbra crossing. The disturbance was violent enough to saturate the ARGOS reaction wheels and cause the vehicle to spin about the yaw axis at 1/8 rpm through the following eclipse period. This spin resulted in the vehicle automatically switching to a safe mode known as "sunsafe" which sheds non-essential power loads and points the solar arrays at the sun to maximize chances of survival. Once ARGOS exited eclipse, the vehicle was recovered through normal recovery procedures, and no long-term impacts have been observed.
